# **COASTAL EROSION AND INUNDATION ASSESSMENT**

Enviro-Tech Consultants Pty. Ltd. 2023. Site Coastal Erosion and Inundation Assessment Report for a Proposed Visitor Accommodation, WHITEMARK WHARF- 16 Esplanade - Unpublished report for Jo Youl by Enviro-Tech Consultants Pty. Ltd., 25 May 2023.

Enviro-Tech Consultants Pty. Ltd. (Envirotech) were contracted by Jo Youl to prepare a Coastal Erosion, and Inundation Assessment for proposed visitor accommodation at Whitemark Wharf - 16 Esplanade – Flinders Island which is herein defined as the Site.

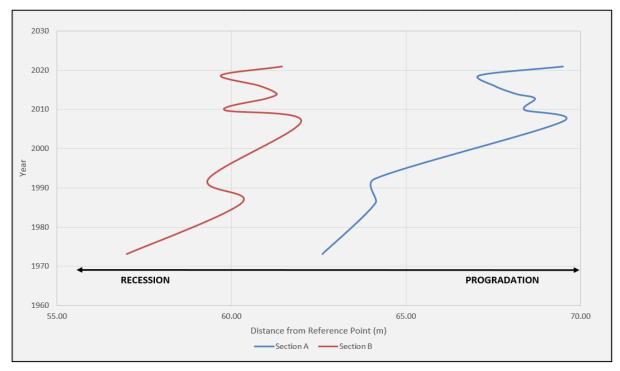
Figure 2 Measured coastline recession as distance of vegetation line relative to a fixed reference point

At both Section A and Section B sites, there is documented evidence of historic coastline progradation since 1973. It is apparent that prior to 1973 that within the Project Area there has been coastal erosion on the southern side of the jetty and accretion on the norther side of the jetty from north to south directed longshore drift.

The observed trend of sand accretion (progradation) within the Project Area which is inconsistent with local/regional trends. Previous reporting (GES 2020) has identified active erosion 200 metres to the north and 300 metres to the south of the Project Area.

It is apparent that there may be an increase in sediment supply within the nearshore zone which is causing localised accretion. As observed at many other locations across the State, oversupply of sediment is resulting in the leeward entrapment of sediments within embayment's where it would not ordinarily been entrapped before onset of sea levels rise. Therefore, the groyne affects historically observed at the Site is probably becoming less pronounced more recently due to abundant sediment supply within the system.

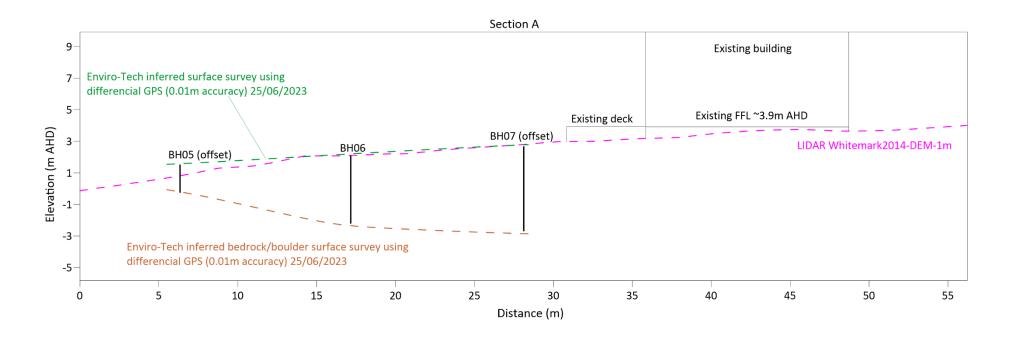
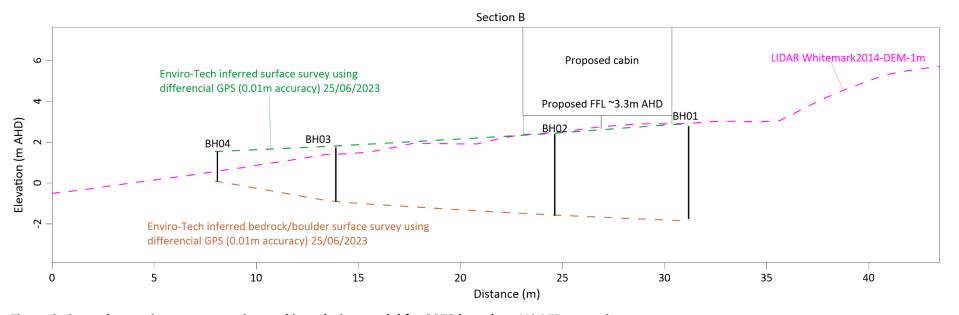
Figure 3 Coastal recession, storm erosion and inundation model for 2073 based on 1% AEP scenario

The bedrock substrate was surveyed beneath the Site in anticipation that active erosion processes will need to be managed deepened building foundations into the stable foundation zone. Ordinarily, where beach recession is observed, a stable foundation zone analysis is required. In this case, given the observed beach propagation within the Project Area, the sandy soils observed within the building envelope are modelled to remain stable by 2100. This assessment also factors in the observed 4 to 5 m³/m storm erosion demand.

- Establishment of the proposed structure on blade(screw) piles which are founded onto the underlying bedrock.
- Relocation of the structure

Any proposed foundations for the development must comply with the AS2870 (foundation assessment)report attached to this document.

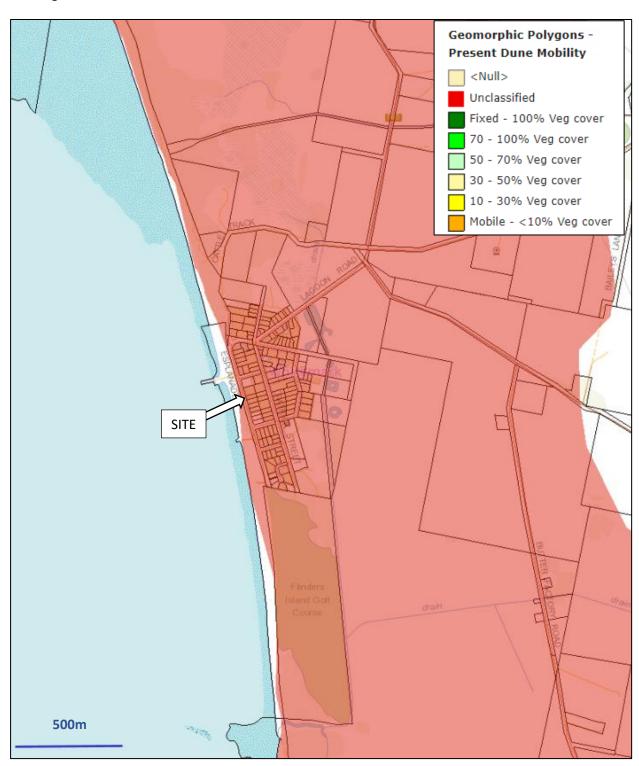
Figure 4 Dune mobility classification (The LIST)

Dune mobility at the site has not been classified (Figure 4). In accordance with the LIST mapping, dune mobility classification is based on vegetation cover. Using the same system, the dune landform at the Site is identified as having 70 to 100% vegetation coverage and are therefore defined at being 'transitory' according to Mowling (2006). As the Site comprises greater than 10% vegetation, the Site is not classified as being mobile.
