Ordinary Council Meeting 21 February 2024 Attachments

Please find CBM's planning application for 1x new house proposed at 12 Munro Place, Whitemark on behalf of the Flinders Island Aboriginal Association Incorporated. The 2-Bed dwelling is sized at 77.5m². Approval has been granted by Homes Tasmania (landowner) to allow FIAAI permission to lodge this planning application.

Development:	1x 2-Bed Dwelling.
Address:	12 Munro Place, Whitemark TAS 7255.
Client:	Flinders Island Aboriginal Association Incorporated (FIAAI).
Planning Scheme:	Tasmanian Planning Scheme – Flinders.
Property ID:	7441546.
Title Reference:	27936/6.
Site Zoning:	10. Low Density Residential.
Use Class:	Residential (No Permit Required).
Qualification:	Single dwelling.

Bushfire Hazard Assessment Report & Bushfire Hazard Management Plan

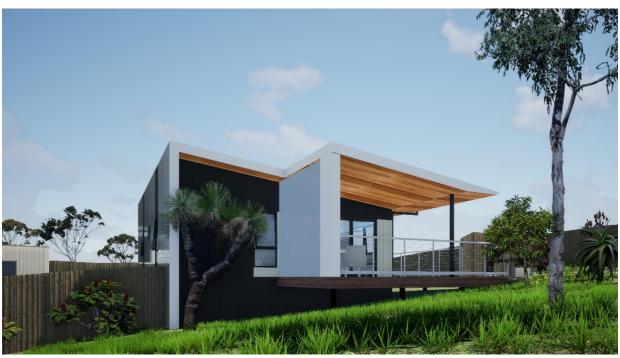
Image 1: Westerly facing perspective from Munro Place.

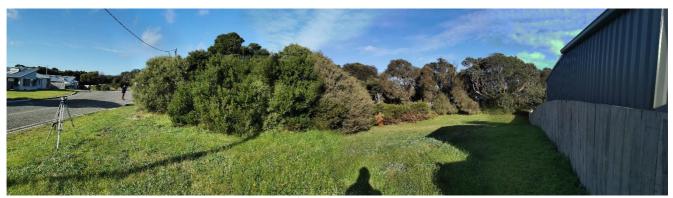
Image 2: South easterly facing photo of 12 Munro Place existing conditions.

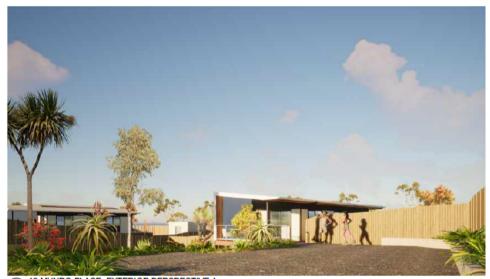
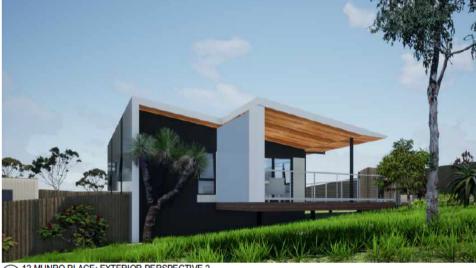
12 MUNRO PLACE: EXTERIOR PERSPECTIVE 2

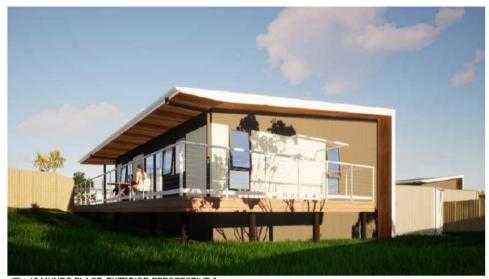
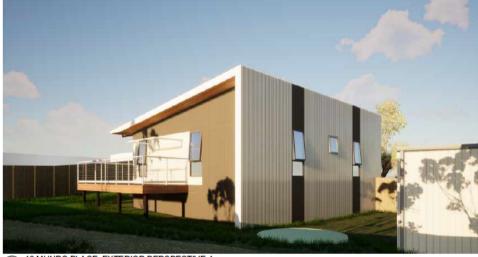
12 MUNRO PLACE: EXTERIOR PERSPECTIVE 3

12 MUNRO PLACE: EXTERIOR PERSPECTIVE 4

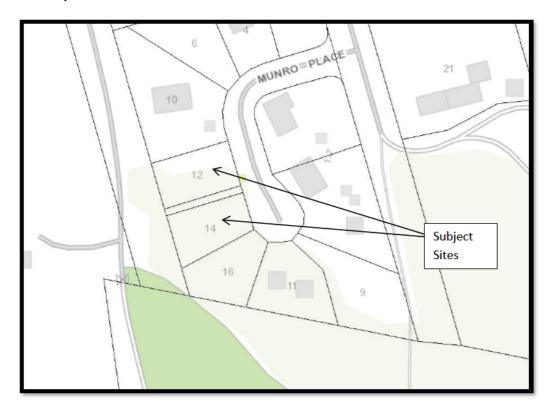
Figure 1: Location Plan of 12 and 14 Munro Place, Whitemark

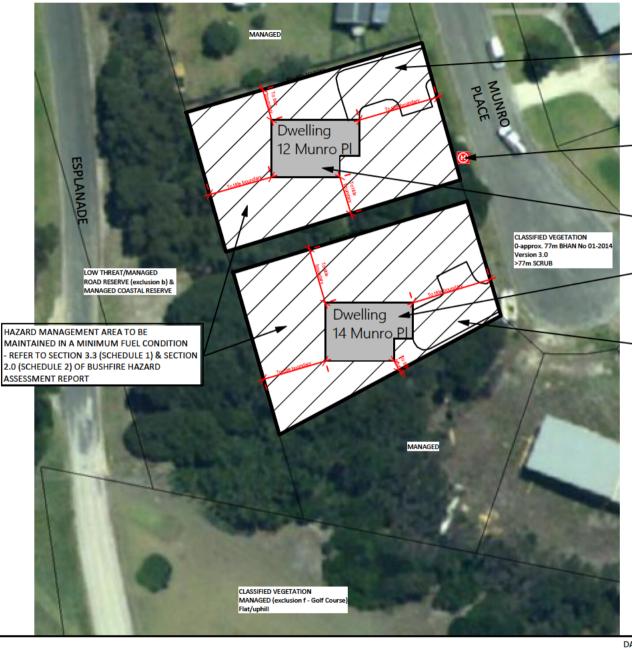
Bushfire Hazard Management Site Plan

PROPERTY ACCESS REQUIREMENTS - REFER TO SECTION 3.5 (SCHEDULE 1) OF BUSHFIRE HAZARD ASSESSMENT REPORT

FIREFIGHTING WATER SUPPLY - REFER TO SECTION 3.6 (SCHEDULE 1) OF BUSHFIRE HAZARD ASSESSMENT REPORT

* THIS BHMP MUST BE READ IN CONJUNCTION WITH BUSHFIRE HAZARD ASSESSMENT REPORT REF: RGA-B2365B, R. GREEN, 27 SEPTEMBER 2023

* THIS BHMP HAS BEEN PREPARED TO SATISFY THE REQUIREMENTS OF THE DIRECTORS DETERMINATION - BUSHFIRE HAZARD AREAS (V1.1)

Refer to the attached BHMP Site Plan in Section 6 of this management plan for specific details on the Hazard Management Area.

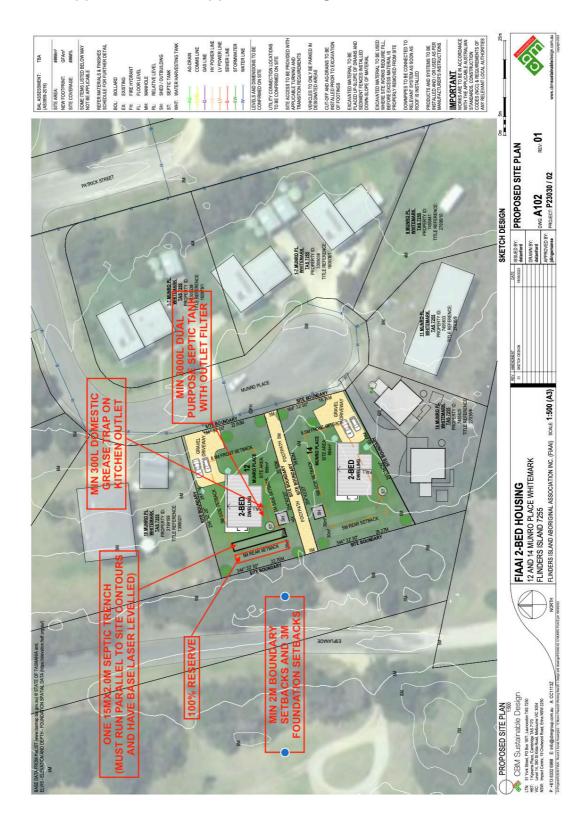
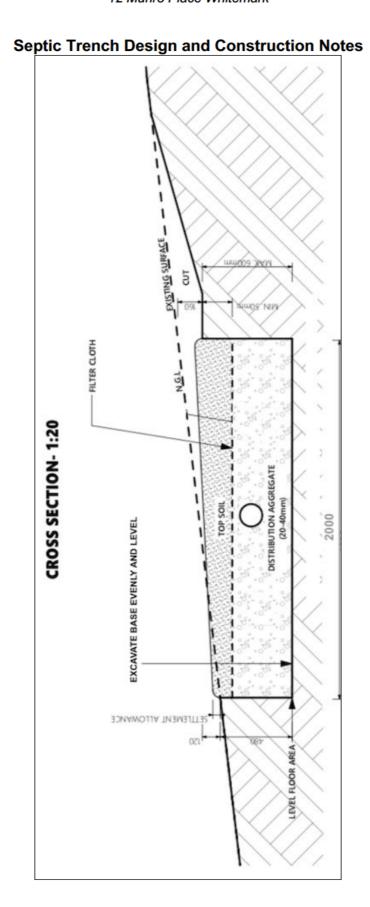
Appendix 2 Land Application Design and Construction Notes

Septic Trench Design and Construction Notes

- 1. Each Trench has the dimensions of 15.0 m X 2.0 m X 0.5 m.
- 2. There is one trench in total as located on site plan giving a total basal area of 30 m² (See Appendix 1)
