## Whitemark Landfill EPN 7191/2

### Review of Environment Management Plan and Remedial Site Works

# GROUNDWATER MONITORING REPORT

## Inspection of Unused Refuse Cell

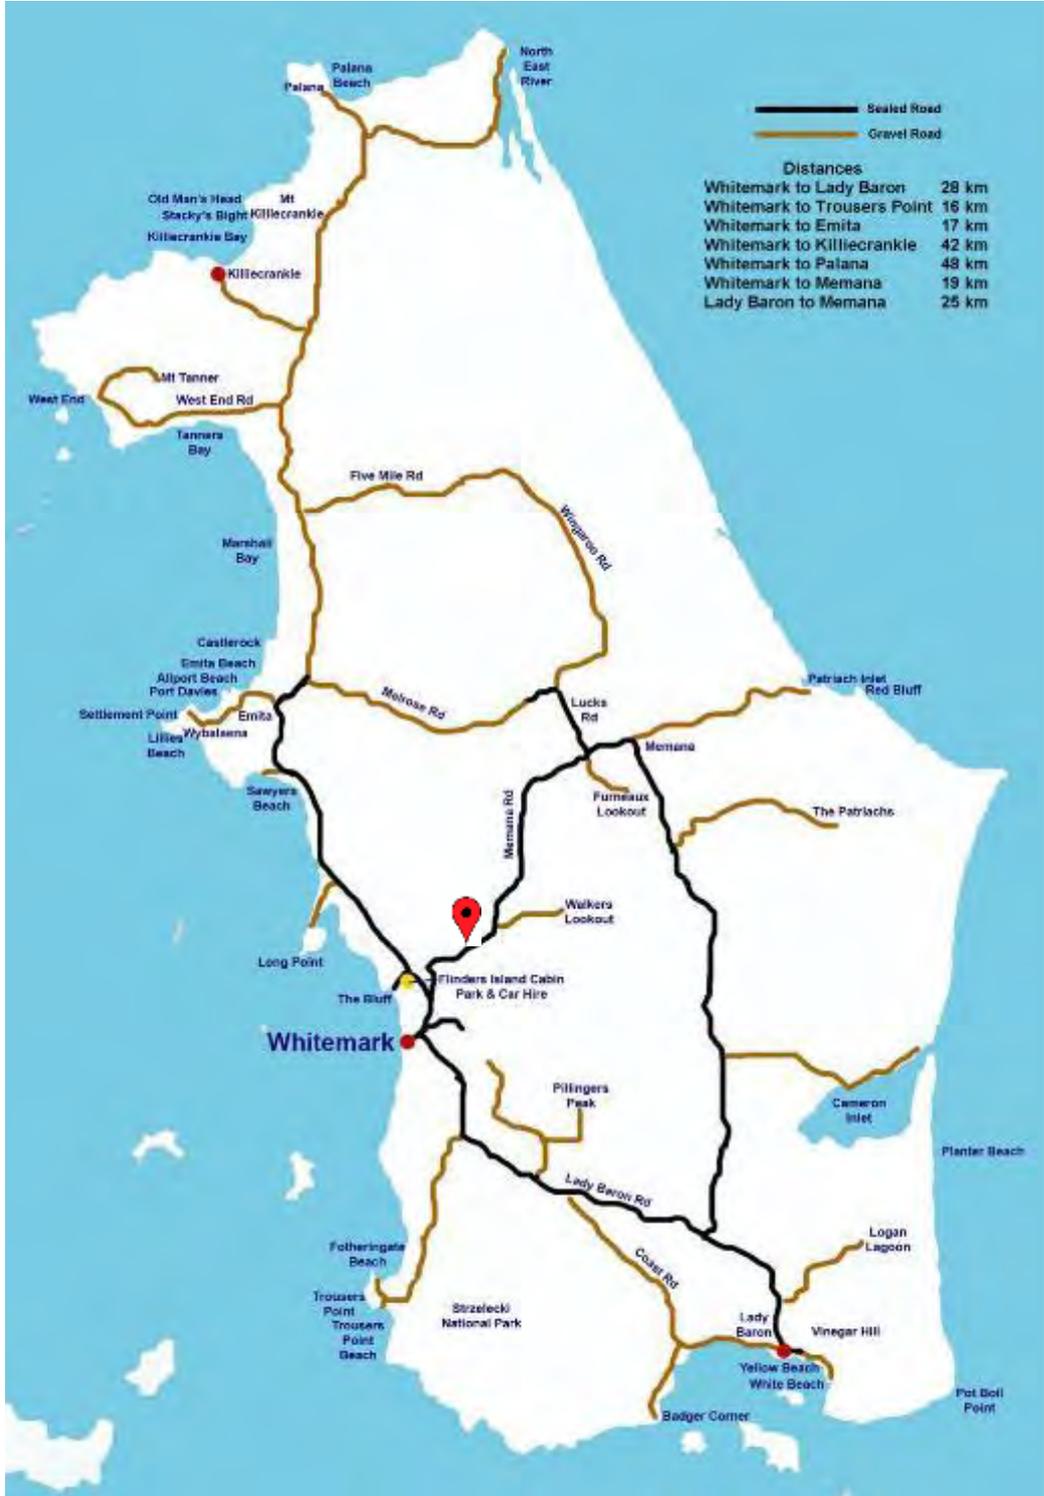
Figure 1: Site Map

The Whitemark Landfill is located approximately seven kilometres North East of the township of Whitemark, address being: 419 Memana Road. Refer to figure 1 for the site location.

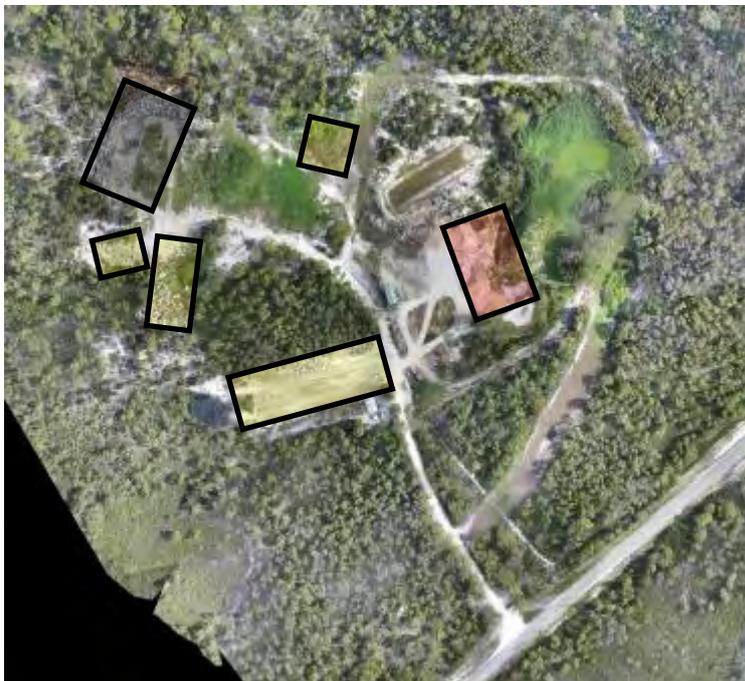
**Figure 1: Landfill Zones**

Zone 1:	Resource Recovery areas;
Zone 2:	Inert landfill;
Zone 3:	Putrescible landfill

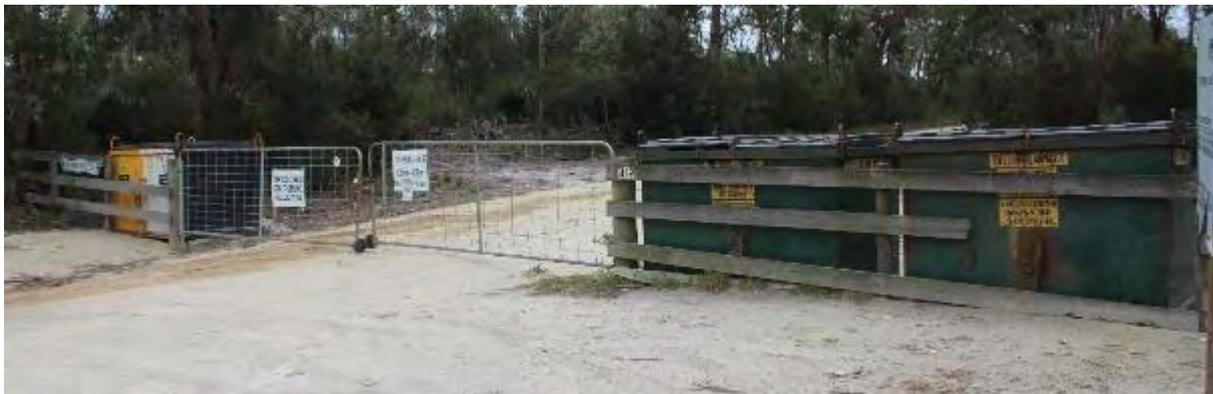
**Figure 2: Bins at the front of the Whitemark site (after hours access)**

There are currently a series of bins at the front gate, which will be removed early in the next financial year. Bins may be replaced for peak periods such as the Christmas break.

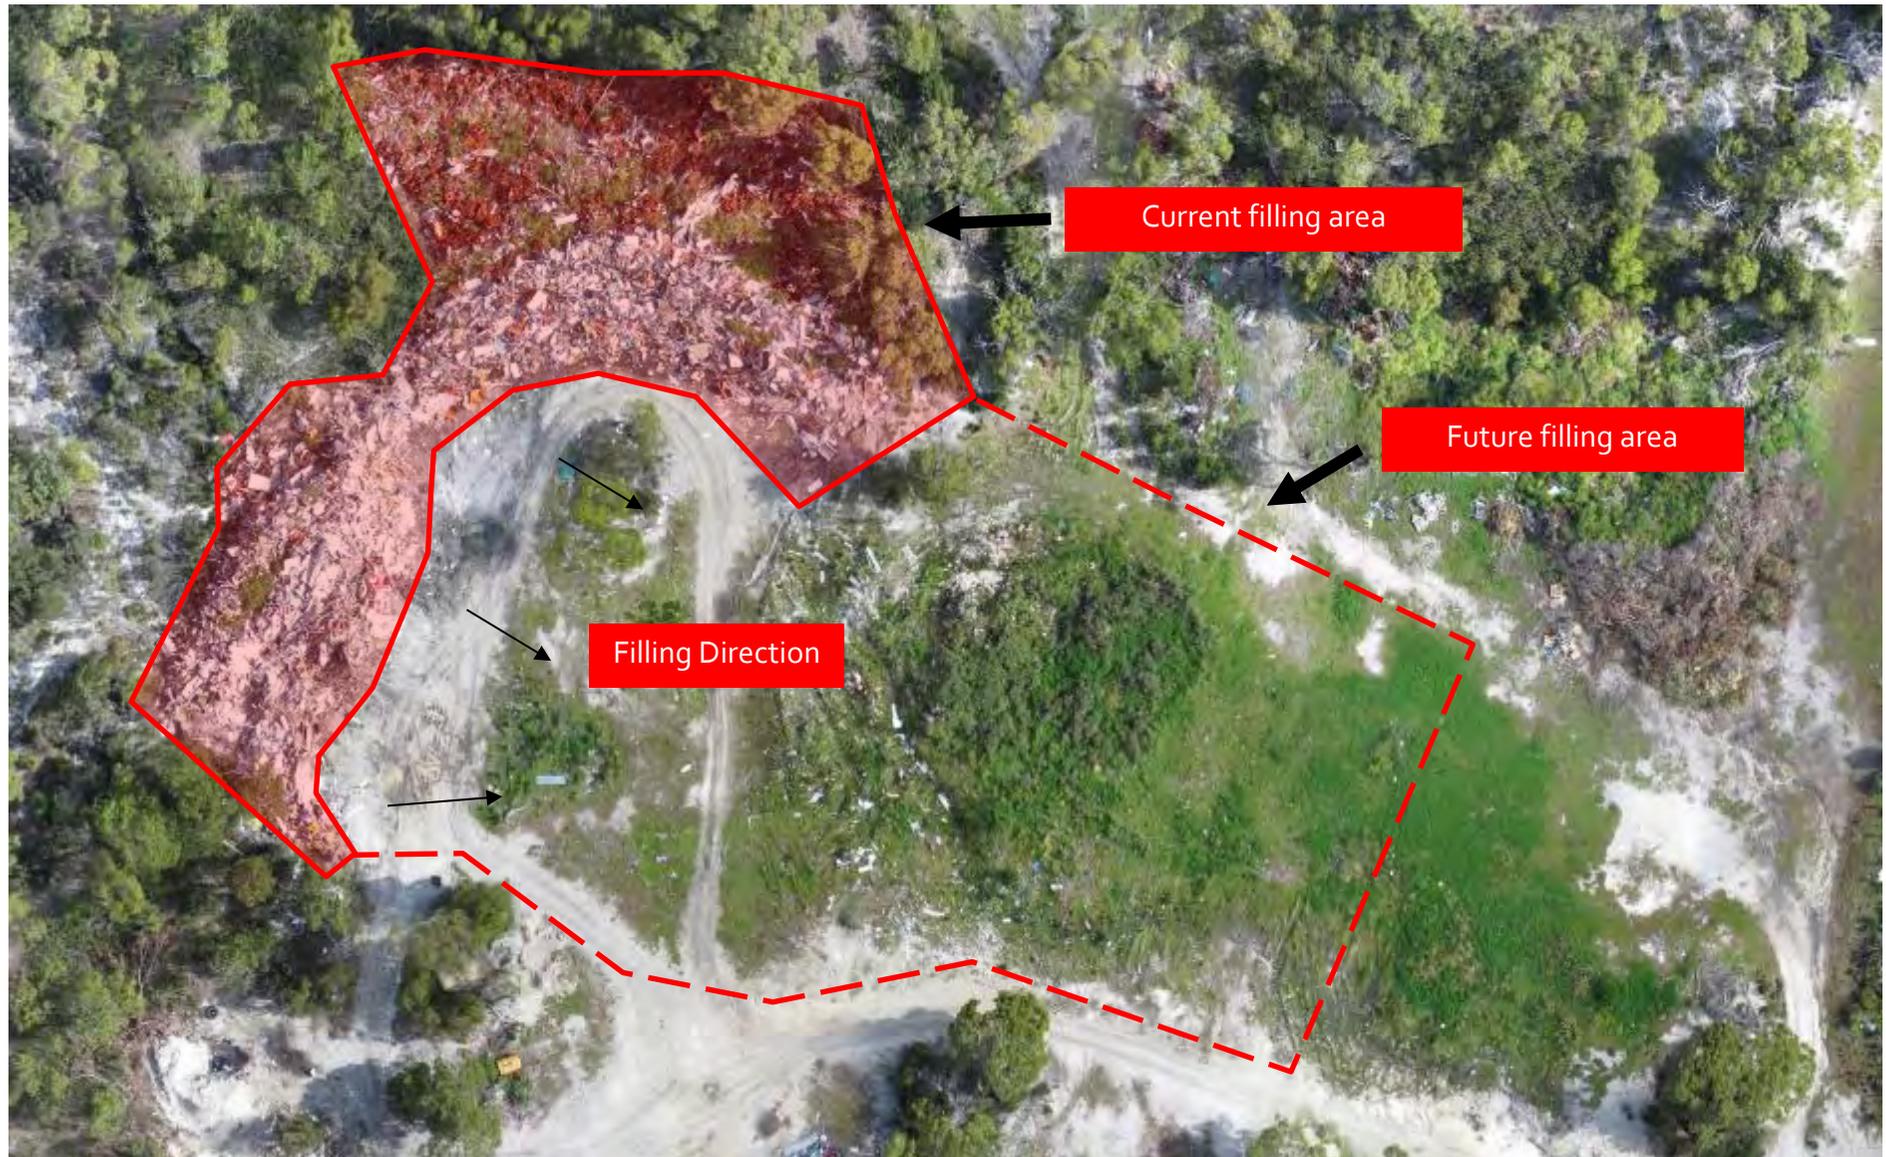
Figure 3: Inert area filling plan

- Compaction and shaping of these areas will be conducted using Councils D6R Dozer. The lift will not exceed two metres high and work into the middle of the inert area. Cover material will be used from stockpiles onsite (Figure 3)

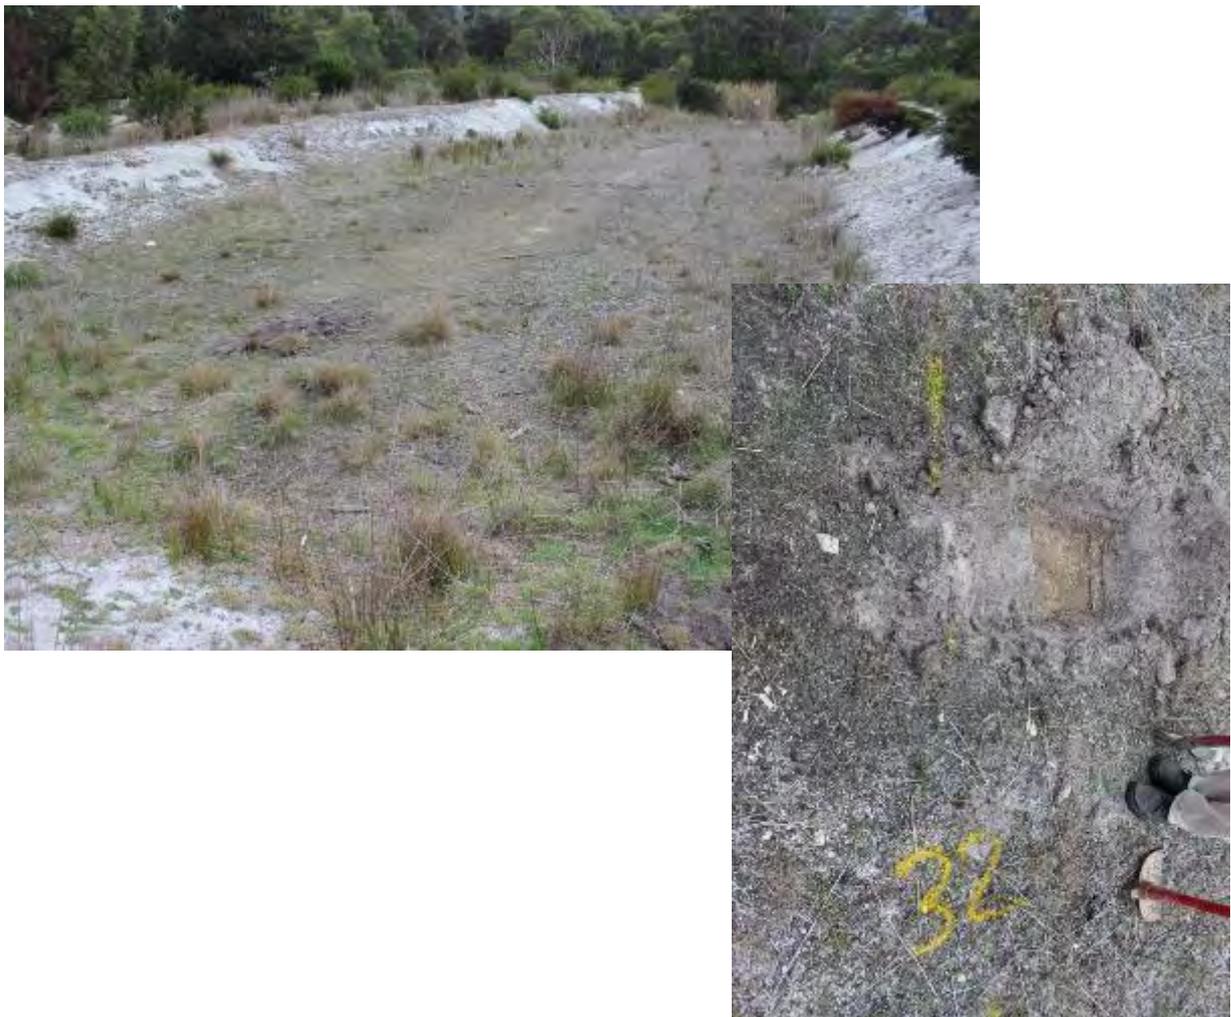
**Figure 4: Putrescible GCL Cell - March 2016**

Due to the GCL being left uncovered to the elements Council engaged a consultant to inspect and test for the permeability qualities of the cell. The report by David Jolly indicates both the permeability test results as well as amended design options for future use. A copy of the report forms Appendix 3 of this report.

Concerns regarding this cell are:

- Original design quality;
- Leachate collection system at base of cell; and
- Overall size and shape of the cell with respect to the filling and achieving batters that would abide by the LSG.

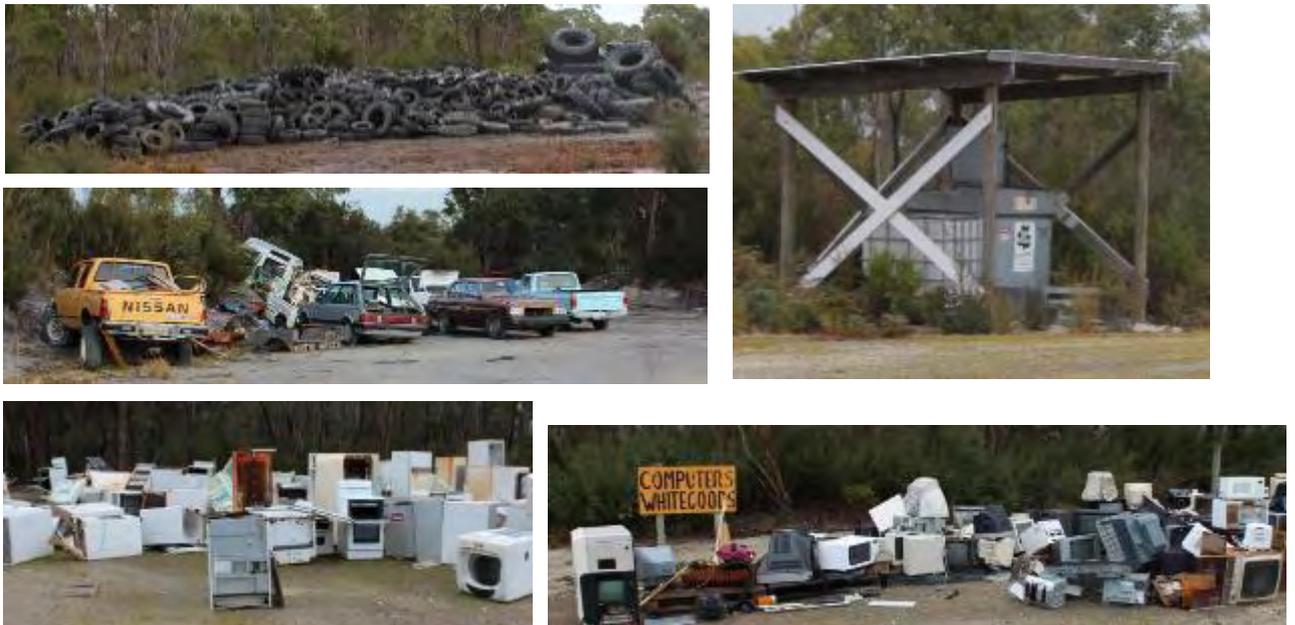
**Figure 4: Stockpiles throughout the site.**

- Whitegoods; - Ewaste;
- Glass bottles; - Aluminium, cans;
- Tyres; - Vehicle batteries;
- Engine oil; - Scrap vehicles;
- Greenwaste; - Concrete; and
- Steel, including fencing wire.

Through the *Waste Management Strategy*, Council is investigating options for all waste materials. This includes recycling, reuse and stockpiling.

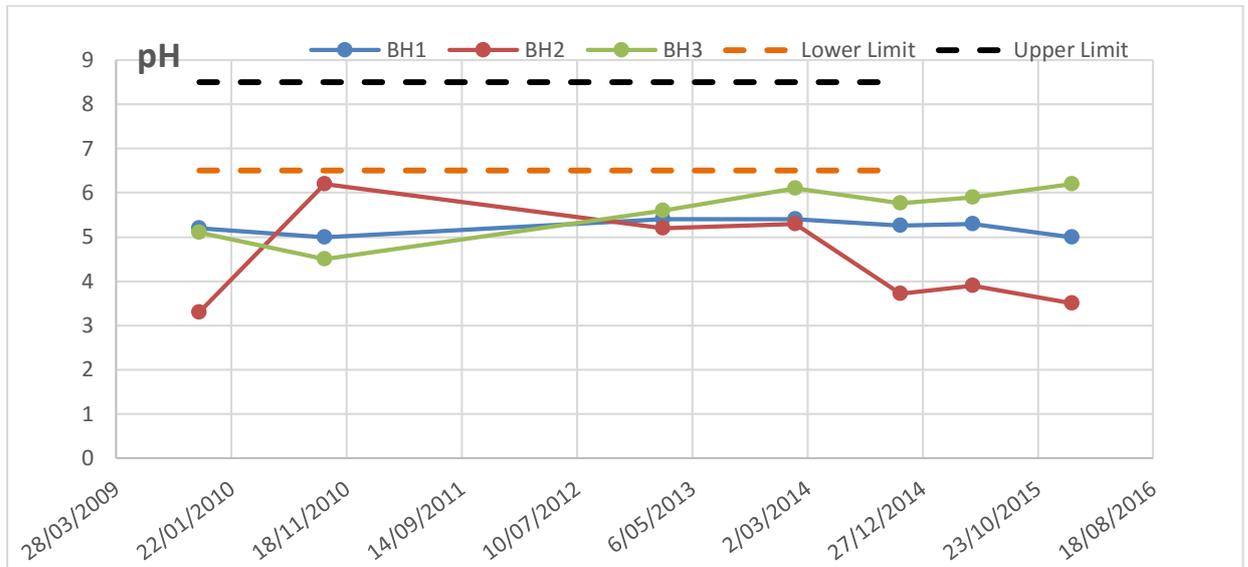
pH results in bores 1 and 3 have shown consistent and similar trends. Bore 2 results shows the largest variation. All bore results obtained are below and outside of the ADWG pH guidelines of 6.5-8.5.

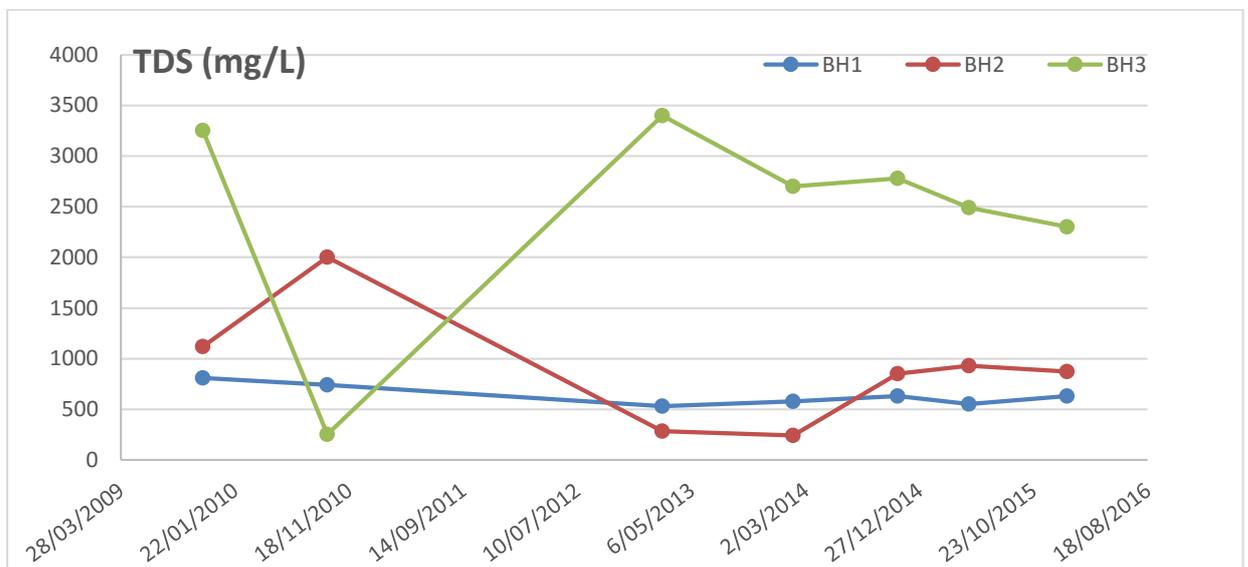
Concentrations of TDS are generally used as an indicator for drinking water quality based on aesthetics and taste value. TDS but can be indicative of unnatural movement of material related to changes in land use. Bore 1 shows very consistent TDS values (between 529 and 807 mg/L) indicating fair to good water quality. Bores 2 (243-2000 mg/L) and 3 (251-3401 mg/L) show greater variation with the majority of results for bore 3 being >1200 mg/L indicating unacceptable drinking water quality.

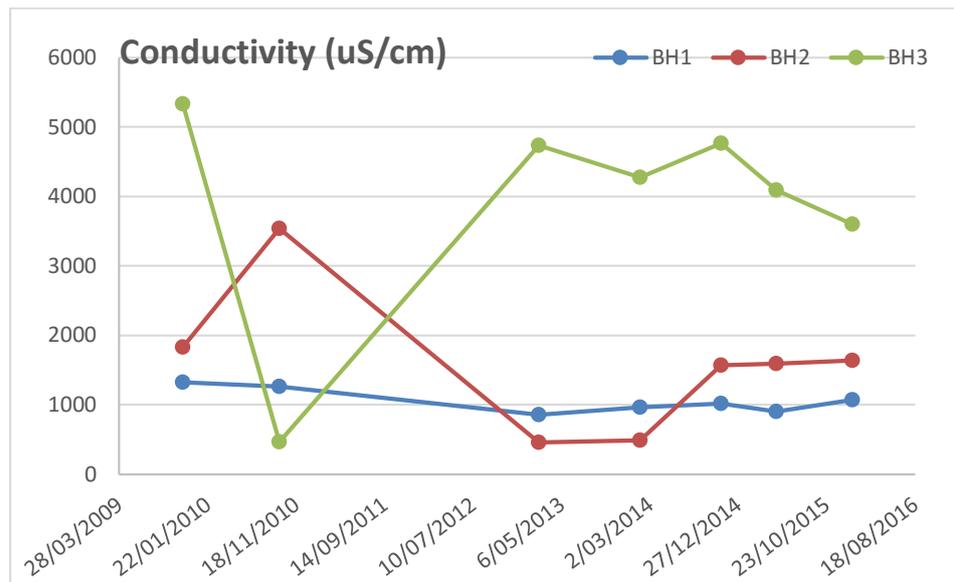
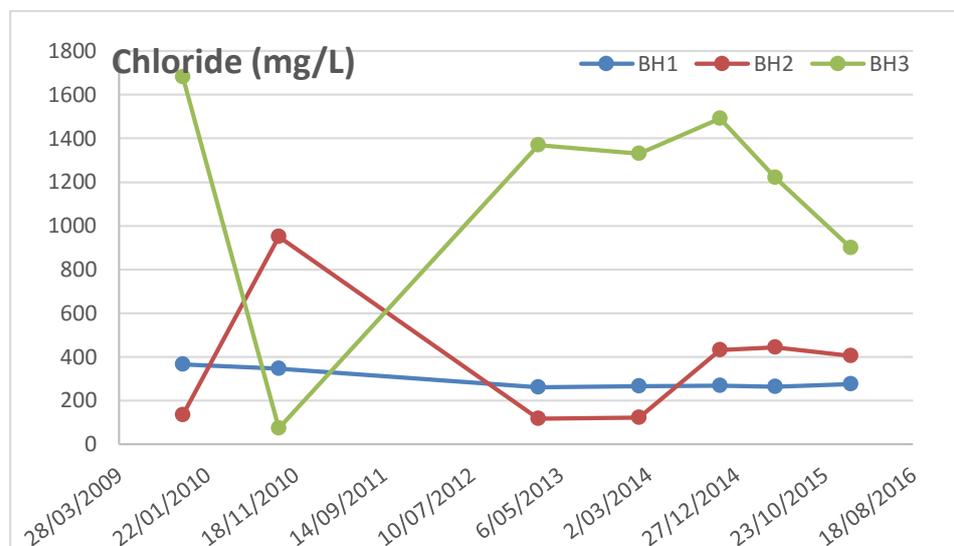
Bore 3 has much higher conductivity levels than bores 1 and 2 and the low conductivity result obtained during 2010 sampling is an anomaly to the otherwise high results. Bore 3 has higher concentrations of chloride, sodium and magnesium than bores 1 and 2 thereby resulting in the higher levels of conductivity. Conductivity is also impacted by temperature and geology. The relationship between conductivity and chloride is shown below with the similar graph trends.

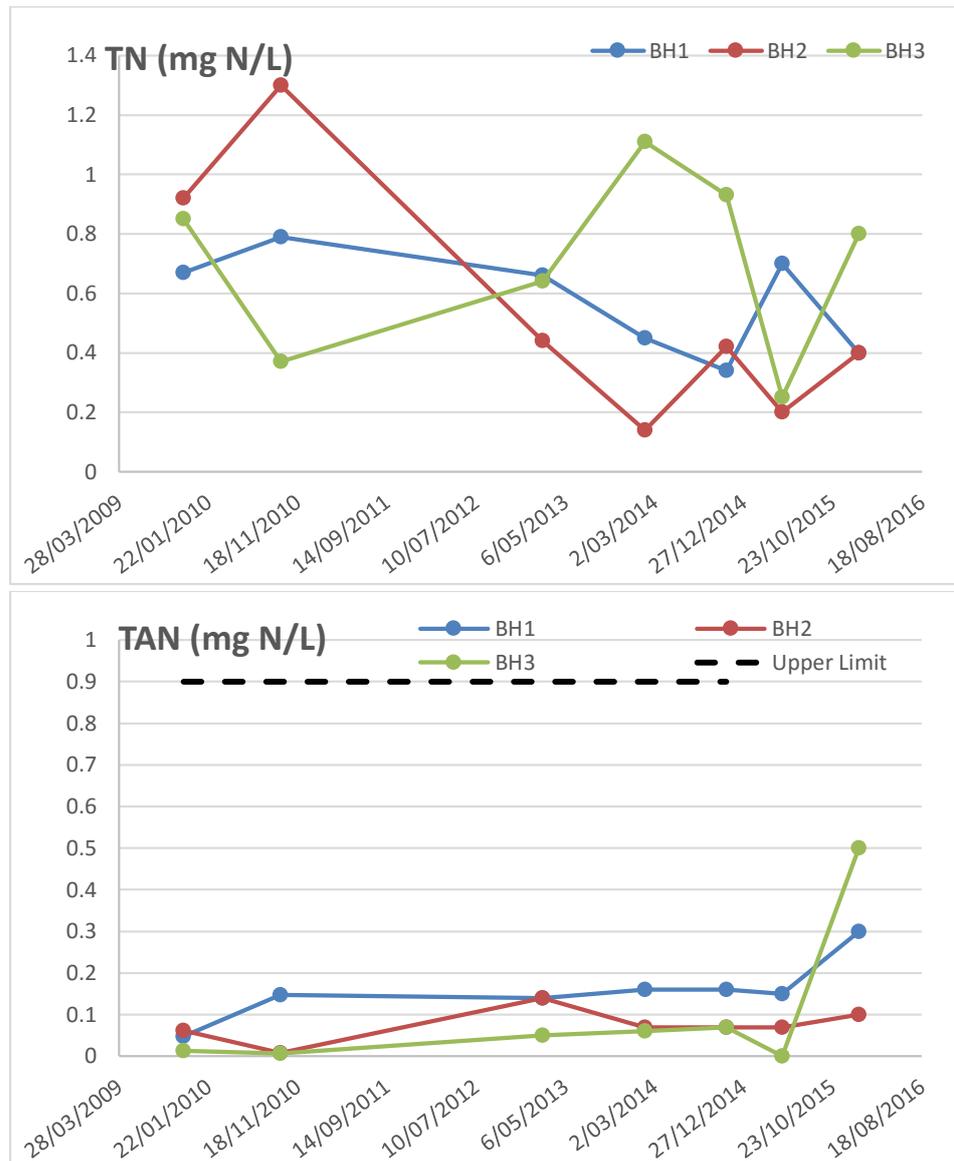
All bores and all monitoring events obtained ammonia nitrogen concentrations below the ANZECC and NEPM guideline value of 0.9mgN/L. All bores show increasing trends between 2014 and 2016. The concentrations in bore 3 being the highest and the rate of increase in bore 1 should be closely monitored to ensure that any potential impact can be addressed prior to values exceed guidelines.

Concentrations of nitrite and nitrate in all bores have not exceeded the ANZECC or ADWG guideline limits.

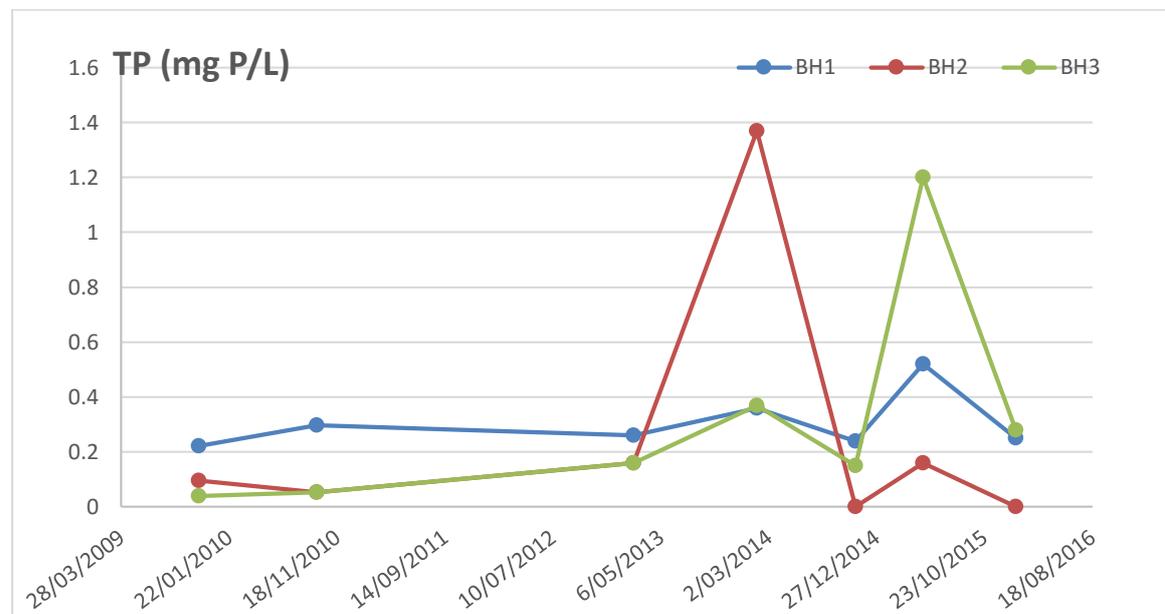
The forms of phosphorous were not individually recorded in 2015 and 2016. Results from 2009-2014 indicated that in Bore 1, the major phosphorus component is SRP whilst Bores 2 and 3 the major components were therefore SUP and/or PP.

The phosphorus form is determined by multiple factors including geology, suspended sediments, particulates and plant matter. The TP result of 1.37mgP/L in bore 2 and 1.2mgP/L in bore 3 is high and may be an indicator of land use impact. The ANZECC trigger values for short term (up to 20 years) values is 0.8-1.2 and all recordings are within that range. The visible spikes in the graph could be related to an incident /spill and in a site investigation this should be looked at.

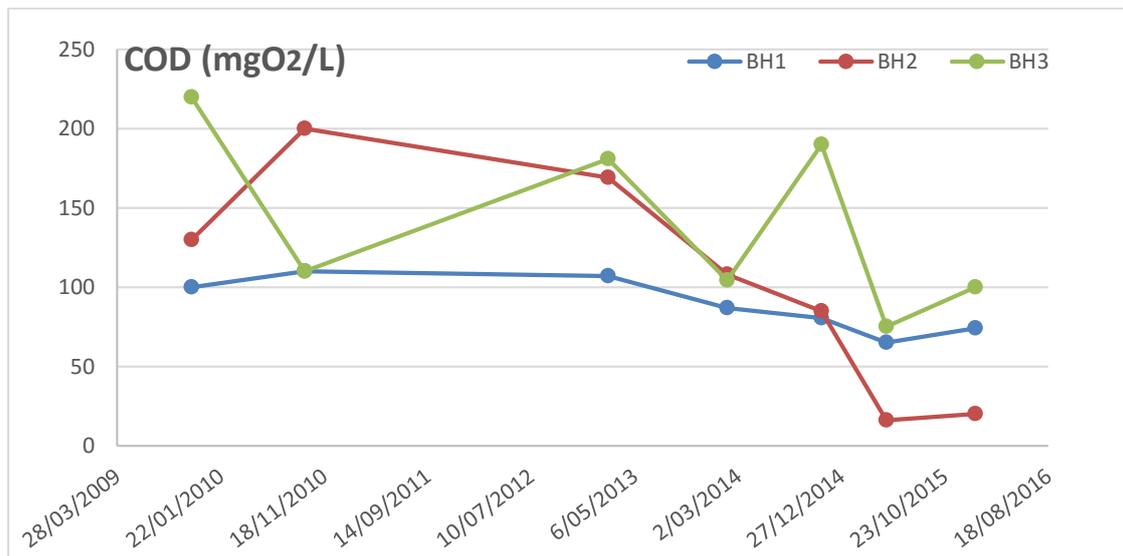
The concentration of COD in the background Bore 1 is high. However, results for Bore 1 are consistent. Concentrations of COD in Bore 2 and Bore 3 are sporadic with no apparent trends. It is likely high spikes are the result of impacts from the disposal site.

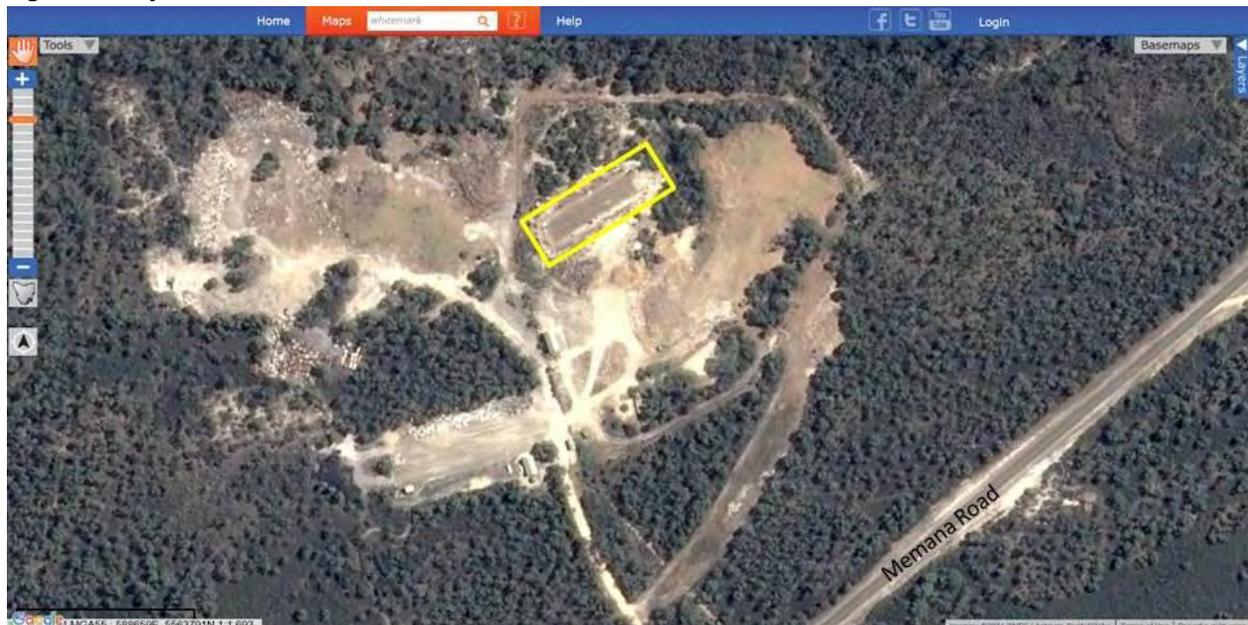
**Figure 1: Subject Site**

The volume of the cell is approximately 2100 cubic meters, has three sides and is lined with a geosynthetic clay liner (GCL); ELCOSEAL X1000. There is an engineered fall from the southern to northern end of the cell. The cell is open at the northern end and water run-off is directed onto a natural land depression. There is no leachate containment infrastructure constructed at the site.

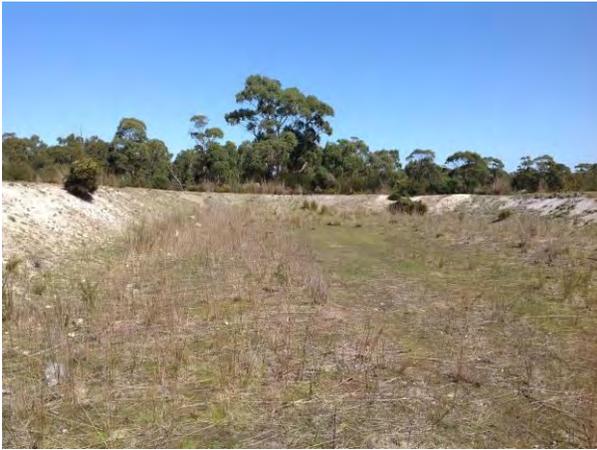
**Figure 2: View towards southern end of cell**

Large areas of GCL have been exposed to the elements for a number of years and substantial decay has occurred and requires replacement. The exposed liner is UV degraded, frayed and torn in places. Small trees and various grasses are growing through the liner.

Only the lower 30 to 50% of the liner has been covered in native soil. Immediately at the base of the batter, cover depth is 200mm.

A GCL sample taken from the western batter (exposed and weathered GCL) for hydraulic conductivity testing did not meet the permeability requirements of the Tasmanian Landfill Sustainability Guide 2004. Refer to Section 3 of this report.

The gradient of each batter is approximately 1V (Vertical) to 1.5H (Horizontal). ELCOSEAL X1000 GCL is not suited for use with this gradient and is designed to be laid on a maximum gradient of 1V:3H that allows the GCL internal shear strength under load to be greater than the interface strength, preventing failure of the liner. Available options are:

4.2 The ELCOSEAL X1000 GCL on in the cell batters is in poor condition and requires replacement.

It is recommended that Council re-grade the cell batters to a gradient of 1V:3H, line with ELCOSEAL X1000 GCL and cap with 300mm of compacted clay cover. The estimated cost is \$24,000 that includes using local labour and machinery. Unused X1000 liner in on-site storage may be used.

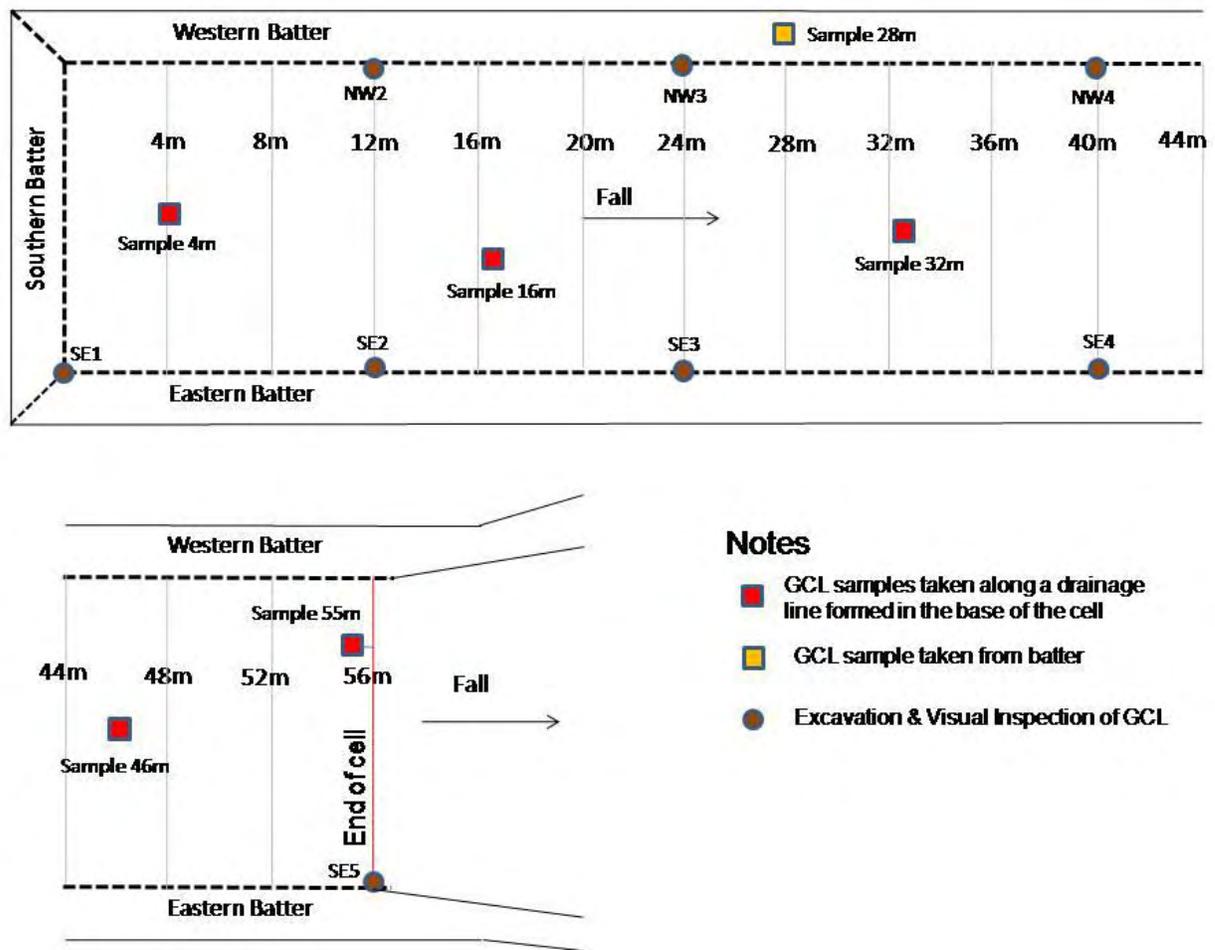
**Figure 4: Sampling and inspection locations**

The cell liner was inspected at 14 points as shown in Figure 4.

Six 30\*30cm liner samples were carefully hand excavated, cut and removed from the cell. On removal samples were immediately photographed and sealed in plastic wrapping to prevent drying and air freighted to TRI Australasia Pty Ltd to determine hydraulic conductivity against test method ASTM D5887. Measured hydraulic conductivity is tabled in Table 3. Refer to full laboratory report in Attachment 7.

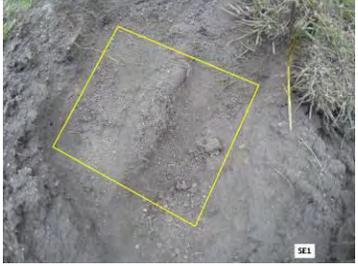
ID	GCL Cover Depth (mm)	General GCL Condition	Photograph
SE1	120	<ul style="list-style-type: none"> <li>• Good visual condition</li> <li>• No physical damage evident</li> <li>• Roots observed at liner depth but no obvious penetration of liner</li> </ul>

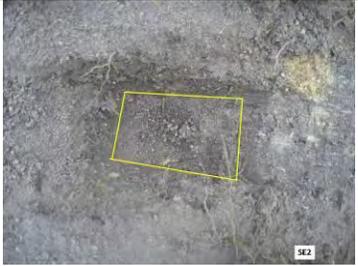
SE2	200	<ul style="list-style-type: none"> <li>• Good visual condition</li> <li>• No physical damage evident</li> <li>• No roots observed at liner depth</li> </ul>

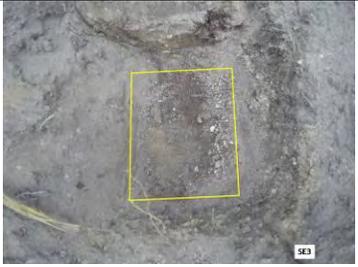
SE3	200	<ul style="list-style-type: none"> <li>• Good visual condition</li> <li>• No physical damage evident</li> <li>• No roots observed at liner depth</li> </ul>

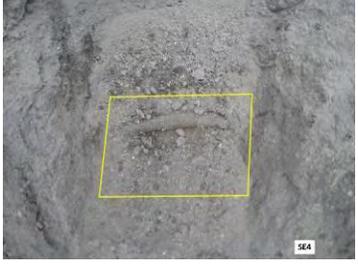
SE4	220	<ul style="list-style-type: none"> <li>• Good visual condition</li> <li>• No physical damage evident</li> <li>• No roots observed at liner depth</li> </ul>

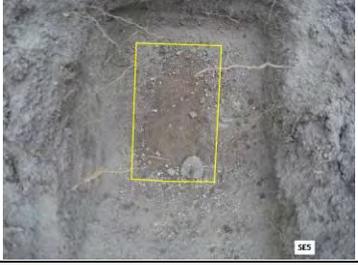
SE5	240	<ul style="list-style-type: none"> <li>• Good visual condition</li> <li>• No roots observed at liner depth</li> </ul>

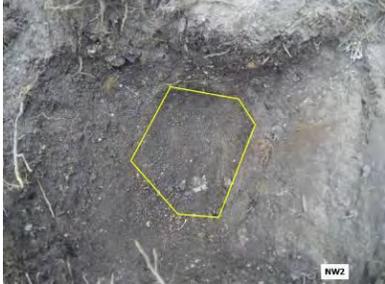
ID	GCL Cover Depth (mm)	General GCL Condition	Photograph
NW2	200	<ul style="list-style-type: none"> <li>• Good visual condition</li> <li>• No roots observed at liner depth</li> </ul>

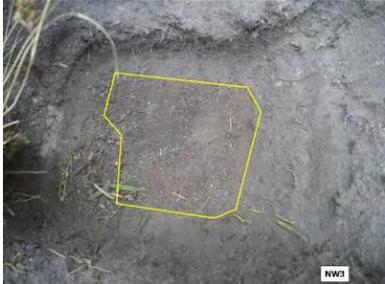
NW3	230	<ul style="list-style-type: none"> <li>• Good visual condition</li> <li>• No roots observed at liner depth</li> </ul>

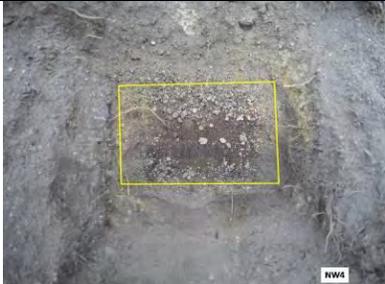
NW4	170	<ul style="list-style-type: none"> <li>• Good visual condition</li> <li>• No roots observed at liner depth</li> </ul>
